DECK SUPPLY SERVICES LLC TEST REPORT

ICC-ES AC273 PERFORMANCE TESTING ON 1-7/8 IN ALUMINUM SURFACE POST TOWER MOUNT

H7830.01-119-19-R0

TEST REPORT FOR DECK SUPPLY SERVICES LLC

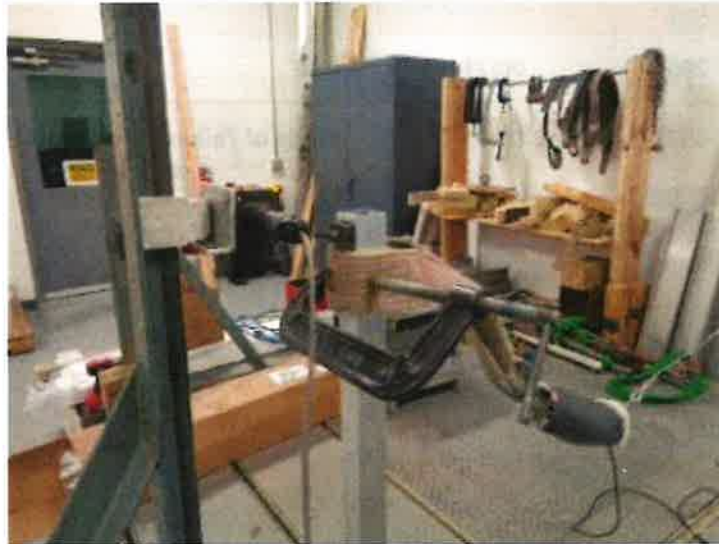
Photo No. 1
Static Post Load Test

Post mount tests were performed per ICC-ES™ AC273, Section 4.3 in a self-contained structural frame designed to accommodate anchorage of a rail assembly and application of the required test loads. The specimens were loaded using an electric winch mounted to a rigid steel test frame. High strength steel cables and nylon straps were used to impose test loads on the specimens. Applied load was measured using an electronic load cell located in-line with the loading system. Deflections were measured to the nearest 0.01 in using electronic linear displacement transducers.

The post mount assembly was installed and tested by directly securing (surface-mounting) the base of the post mounts to a rigid steel test frame (simulated concrete). The post mount to base plate attachment screws were located such that the line of screws was perpendicular to the direction of the applied load (reference Photo No. 4 in Section 9). Transducers mounted to an independent reference frame were located at the top of the post mount, adjacent to the load application strap to record movement of reference points on the post mount. See photographs in Section 9 for test setups.

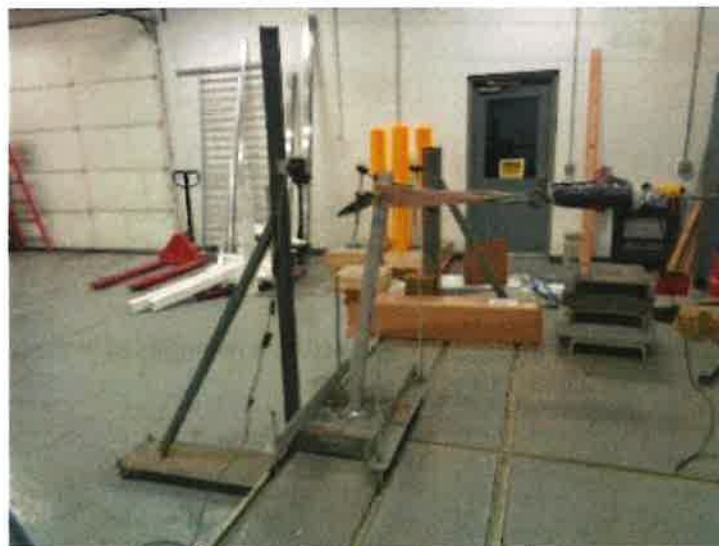
Photo No. 2
Static Post Load Test - Load Applied

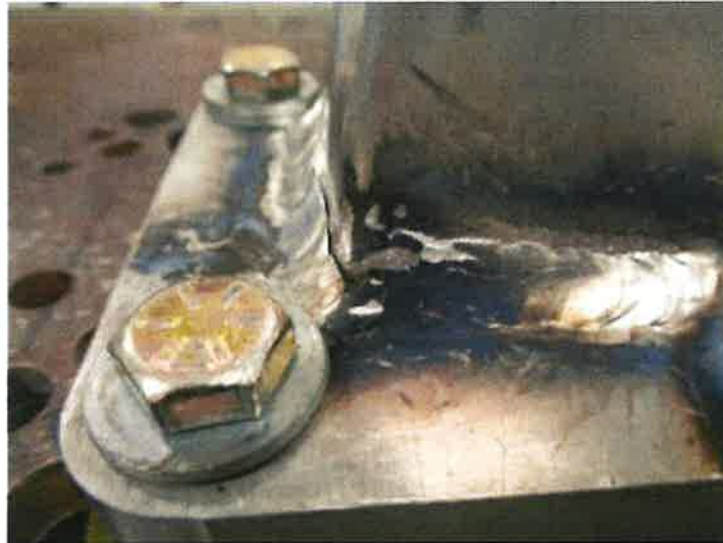
Photo No. 3
Typical Failure at Weld on Base Plate

LOAD LEVEL	TEST LOAD (lb)	E.T. (min:sec)	DISPLACEMENT (in)
200 lb (D.L.)	201	00:22	1.17
Ultimate Load	610	01:05	Mode of Failure: Weld cracked and bottom screws pulled out

LOAD LEVEL	TEST LOAD (lb)	E.T. (min:sec)	DISPLACEMENT (in)
200 lb (D.L.)	202	00:14	1.17
Ultimate Load	582	00:47	Mode of Failure: Weld cracked and bottom screws pulled out

LOAD LEVEL	TEST LOAD (lb)	E.T. (min:sec)	DISPLACEMENT (in)
200 lb (D.L.)	205	00:21	1.12
Ultimate Load	652	01:03	Mode of Failure: Weld cracked

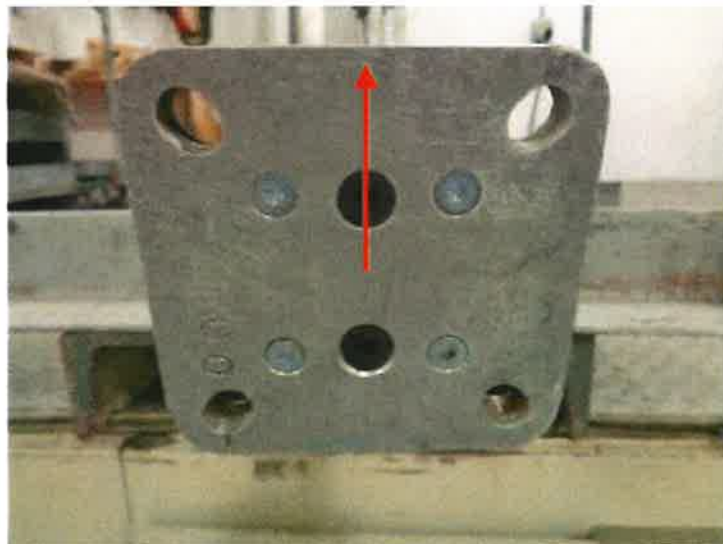
Photo No. 4
Connection at Bottom of Base Plate
(Arrow Denotes Direction of Load)

CONNECTION	FASTENER
Post to Base Plate ¹	1/4 in continuous fillet weld all around; Four #10-24 x 1-1/2 in (0.187 major diameter) T-15 star drive, trim head, type C point, coated steel screws; Two 1/4-20 x 2 in (0.247 major diameter) T-30 star drive, trim head, type F point, coated steel screws
Post Mount to Substructure	Four 1/2 in Grade 8 hex-head bolts with washer

¹ The post mount to base plate attachment screws were located such that the line of screws was perpendicular to the direction of the applied load. Reference Photo No. 4 in Section 9 for test load direction.
